**BENTHIC MACROINVERTEBRATE SURVEYS
CANE CREEK AND HUDGENS CREEK
PUTNAM COUNTY, TENNESSEE
APRIL 2017**

**Prepared for:
City of Cookeville
Public Works-Storm Water Management
45 E. Broad Street
Cookeville, TN 38501**

**Prepared by:
Pennington & Associates, Inc.
P.O. Box 2887
Cookeville, Tennessee 38502-2887
931-268-6035
Pail@twlakes.net**

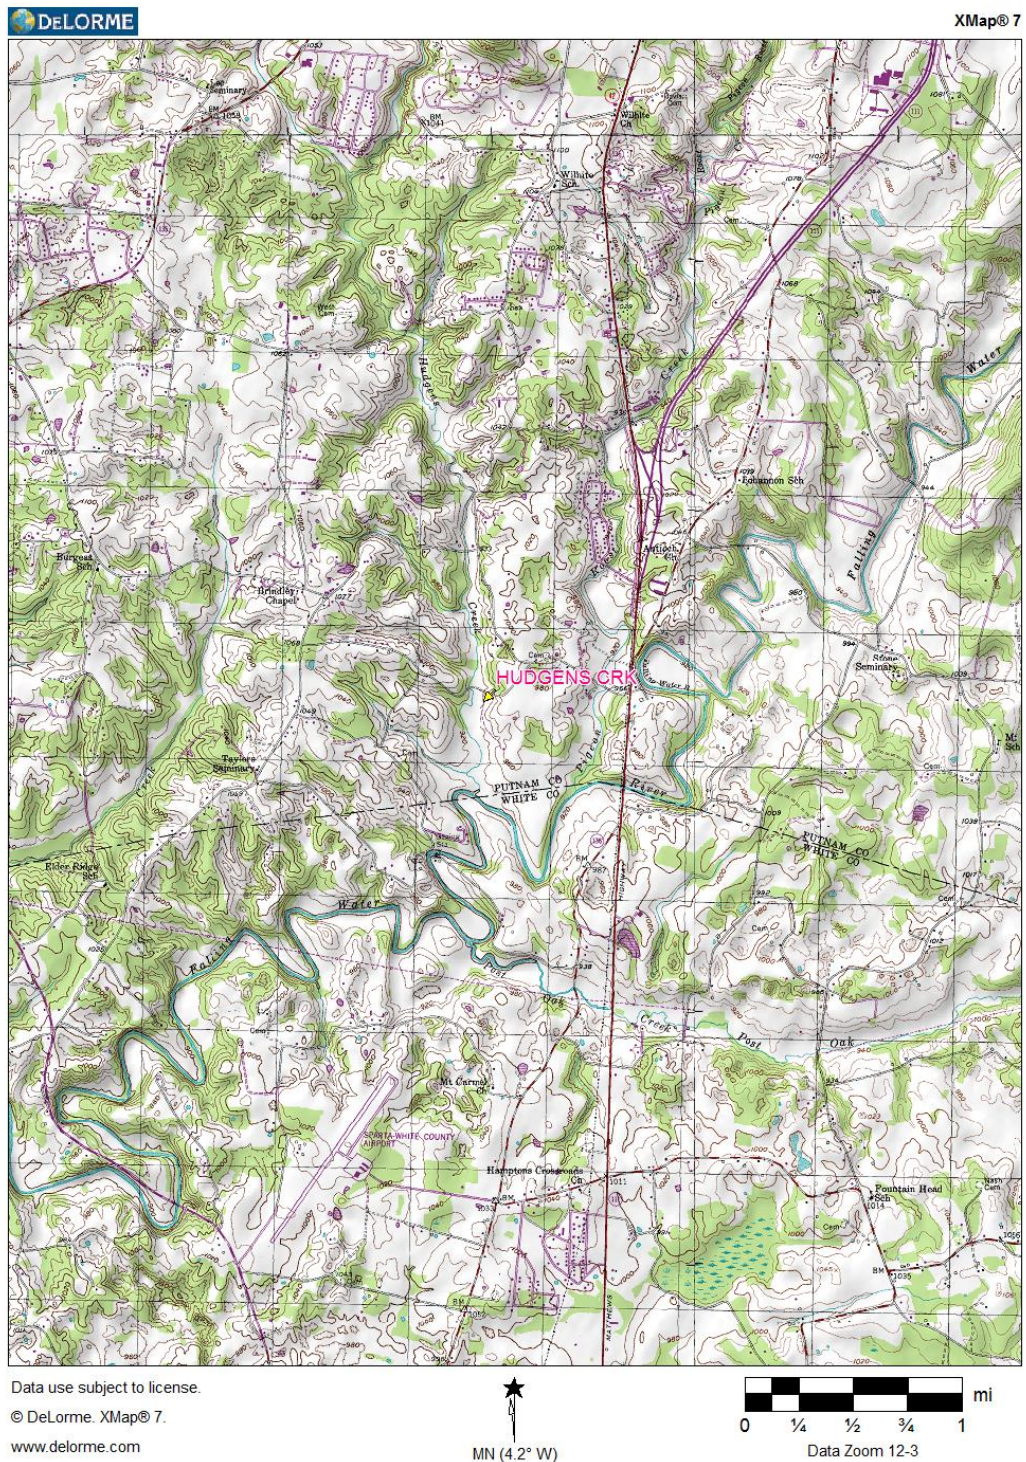
**Figure 2. Benthic Macroinvertebrate Sampling Location Hudgens Creek,
 Putnam County, Tennessee, April 12, 2017.**

Hudgens Creek (HUDGE000.5PU) –Just downstream of South Lovelady Road, Putnam County, Tennessee (N36.08799⁰, W85.51855⁰).

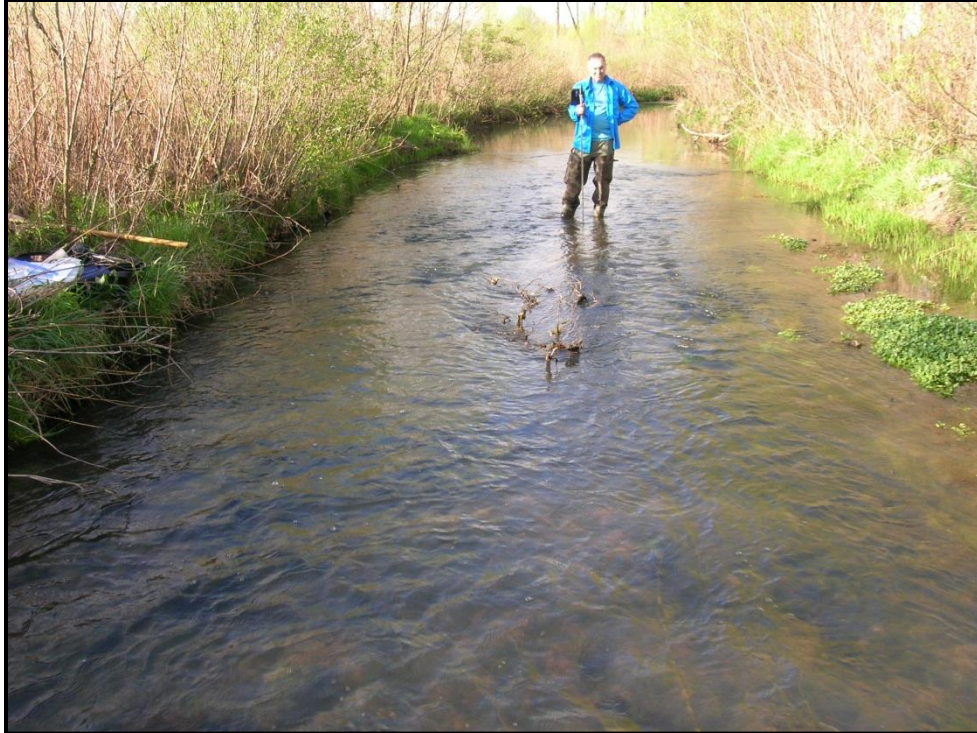
Photo 1. Cane Creek, Putnam County, Tennessee, April 12, 2017.

Cane Creek (Photo 1) originates on the Eastern Highland Rim just south of the City of Cookeville in Putnam County, Tennessee at an elevation near 1100 feet. Cane Creek flows south for approximately 15 miles to its confluence with Falling Water River at the Putnam and White Counties line. The drainage of the watershed upstream of the study site is approximately 5.93 square miles. Usage of the watershed is a mixture of agriculture, urban, residential with some light industry.

Physical characteristics of Cane Creek are presented in Table 1. There was an open canopy (41%) where the samples were taken. The channel was approximately 18 feet wide. Depth was averaged at 0.49 ft and the flow was 6.46 cfs (5.18 cfs when a correction factor was applied). Substrate in the section of Cane Creek used for benthic macroinvertebrate sampling consisted of mostly gravel (73%), silt (10%), cobble (10%) and sand (7%). Habitat was scored as Not Impaired using a consensus of two assessors

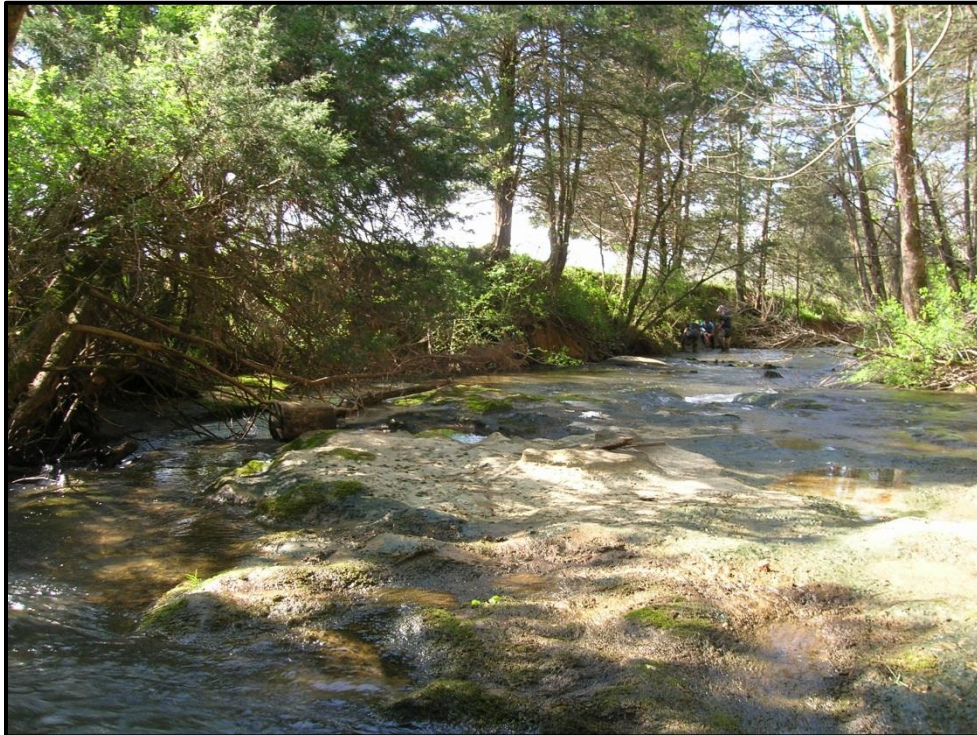
Photo 2. Hudgens Creek, Putnam County, Tennessee, April 12, 2017.

Hudgens Creek also originates of the Eastern Highland Rim just south of the City of Cookeville at an elevation of approximately by 1100 feet. The creek flows south for about 5 miles to its confluence with Falling Water River at the Putnam and White counties borderline.

Characteristics of the physical habitat of Hudgens Creek (Photo 2) are also found in Table 1. The site in Hudgens Creek had a canopy measured to be 82%. The stream channel was 35 feet wide with the channel where flow was measured about 6 feet wide. Depth within the narrow channel averaged 1.05 feet. Flow was calculated to be 19.34 cfs, or 15.47 cfs when a correction factor of 0.8 is applied. The substrate in Hudgens Creek was mostly bedrock (53%), gravel (24%), silt (15%) with lesser amounts of sand (6%) and cobble (2%). Habitat was scored as Not Impaired using a consensus score of two stream assessors.
